# Maintenance Bulletin

AN/TPQ-36(V)8 Shelter	FILE NO.	158	REVISION:
	DATE:	10/30/00	CATEGORY:
SUBJECT:		Title	
Installation of 90 Degree Connectors		SYSTEMS AFFECTED:	
		All AN/TPQ-36 (V)8 Shelters

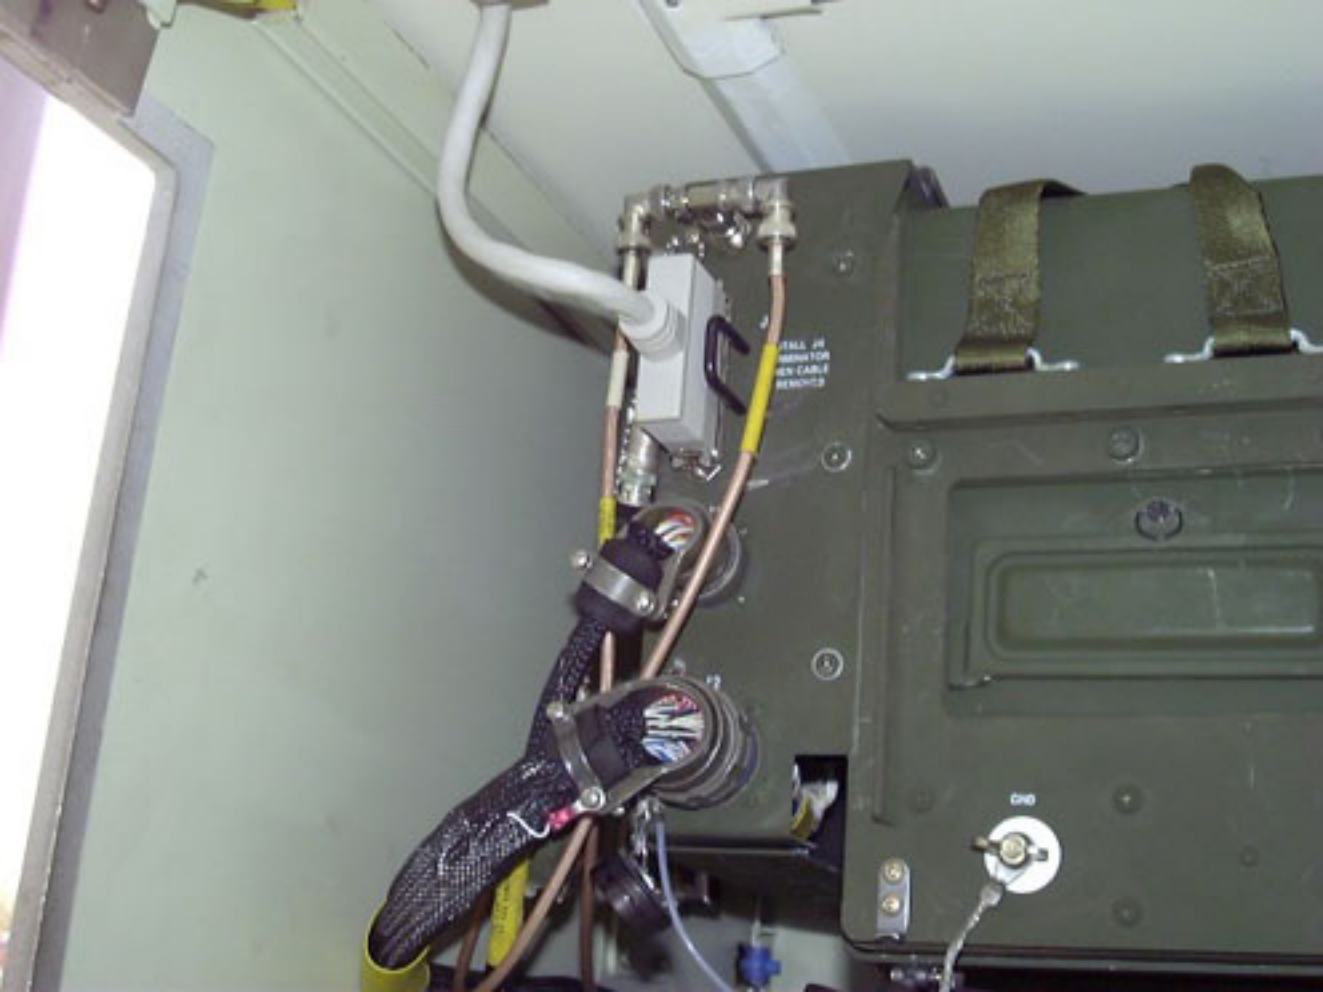
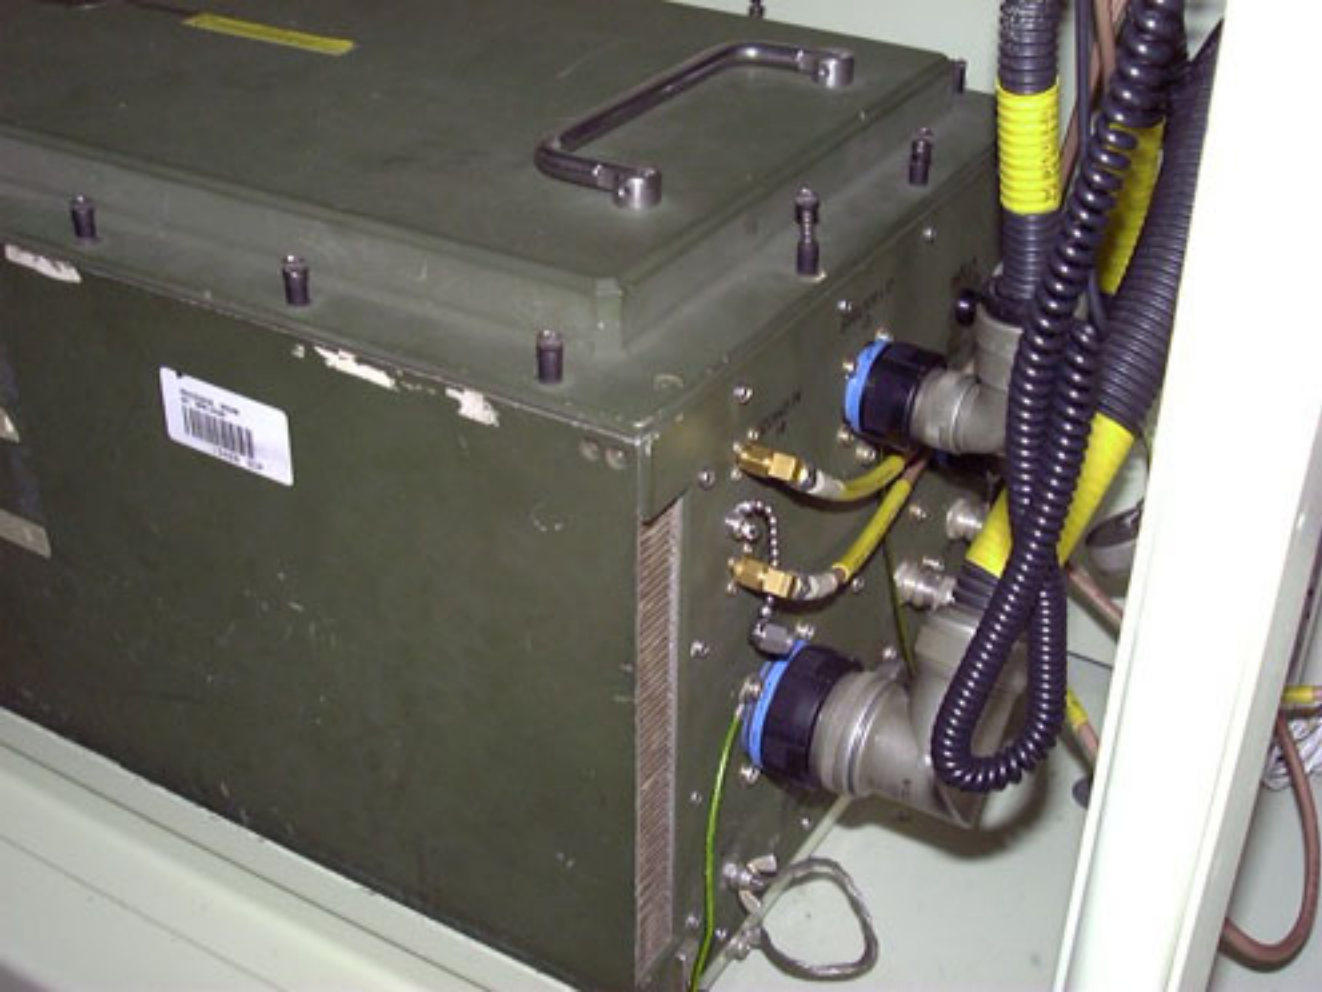
1. Reference: TM 11-5840-380-10 page 1-113 figure 1-43 and the attached pictures.
2. Summary of the problem: Currently, the SMA connectors installed as COHO and 3IFCOMP to the radar processor are perpendicular to the processor. This results in the connectors being damaged from articles dropped on them and items being placed between the processor and the support wall. Additionally, the LAN connector for the left LCU is experiencing the same problem.

3. Corrective action: (Refer to the attached pictures.) Remove the COHO and 3IFCOMP lines from the processor. Install the 90 degree SMA connectors to the processor but do not tighten. Loop the COHO and 3IFCOMP lines against the processor and connect to the 90 degree connectors. Tighten both the lines and connectors. For the LCU LAN, remove the LAN lines. Install the 90 degree BNC connectors to the LCU. Reroute the LAN lines against the LCU and connect to the LCU. Run SFIT and TFIT to verify good connections.
